# Safety Inspection Report

Annual Inspection

## Orchard Lane

Site name: **Orchard Lane**  
Date of inspection: **13 June 2022**  
Inspector: **David Owen**

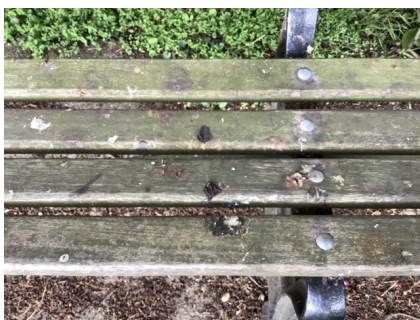
Bird fouling present.

Medium

8

It is recommended that playground equipment be regularly checked for bird fouling - if found, the affected items should be cleaned with a disinfectant solution.

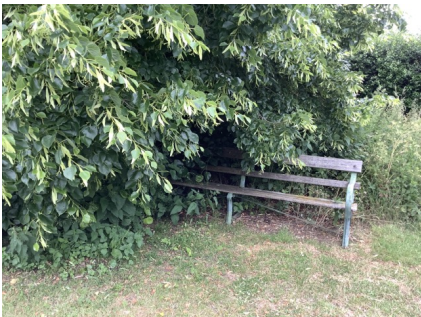
Encroaching vegetation or trees.

Cut back vegetation to seat near cableway as seat is unusable.

Medium

8

Remove.

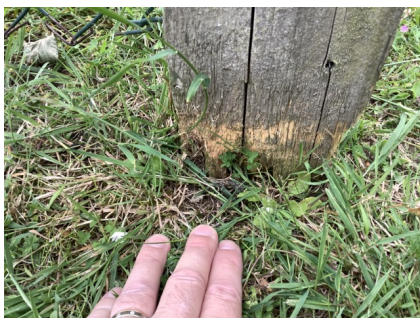
There is decay to timber components which may affect structural integrity. We do not recommend replacing rotten supports with timber posts which are directly set in the ground due to the increased problem of timber rot, especially in posts in contact with the ground.

Decay setting in due to heavy strimming. Replace affected parts.

Medium

8

Replace decayed components where possible and plan replacement of item. Check on a routine basis, especially at ground or foundation level.

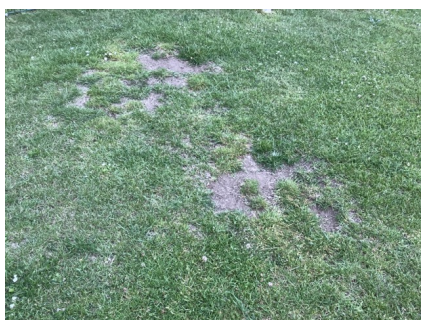
Surface is wearing.

Goalmouth/s wearing. Either soil & seed affected area or re-turf affected area.

Low

7

Read the notes for further action.

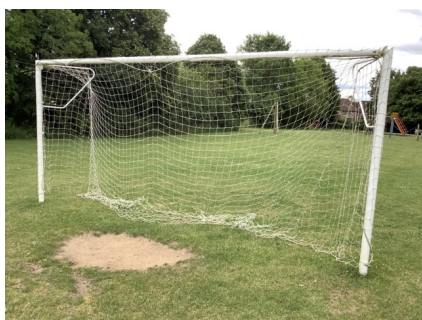
The structural tests within EN 748 / EN 16579 have not been done during this inspection. These can be conducted by separate arrangement.

Very low

0

Arrange to conduct the appropriate tests.

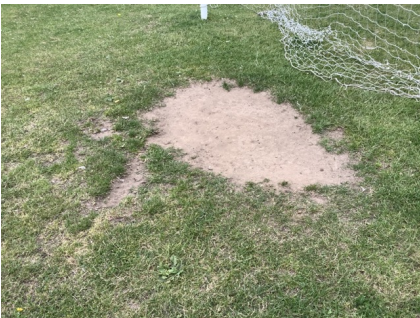
Surface is uneven.

Goalmouth repairs uneven. Level out.  
Far side goalmouth has a deep hollow. Repair.

Low

7

Make good.

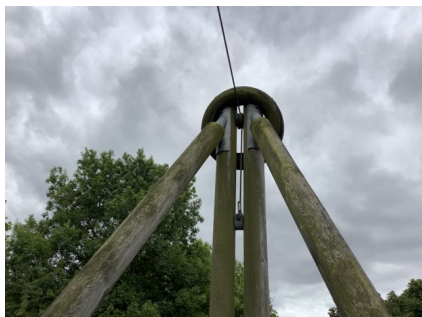
Cables have been known to fail under load due to wear and corrosion. This is generally where the cable enters into a tube, top bar or similar, where the wire is in contact and wears and frays over time, but can happen anywhere on the cable. It is important to carry out a full dismantling inspection at least once per year. Damaged cables require replacement. This cannot be determined during an annual inspection, and is excluded from our inspection. This finding is generically high risk and action is required. Refer to the manufacturer's instructions to ensure the correct check is carried out.

High

15

Conduct an appropriate dismantling inspection according to the manufacturer's instructions, and at least annually. The trolley mechanism can be checked at the same time.

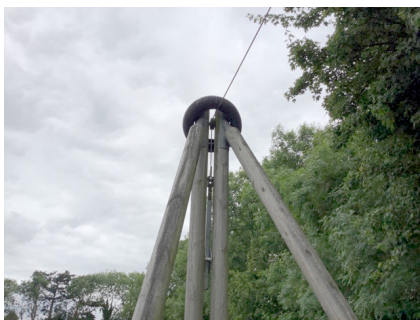
Additional comments are noted below.

Remove tyres from the top of both supports.

Low

7

Read the notes for further action.

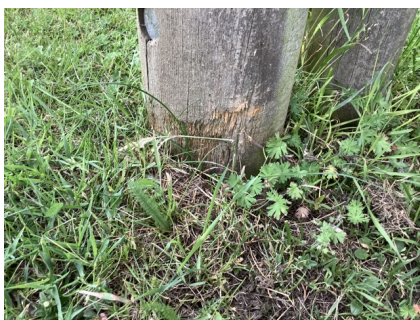
Strimmer damage to supports is likely to accelerate timber rot.

Medium

9

Prevent further damage.

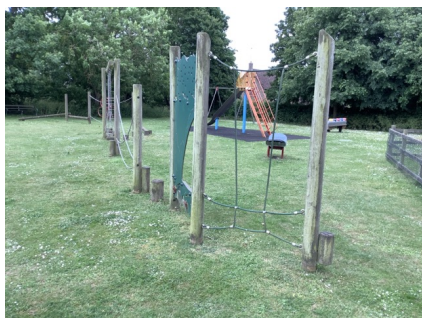
This equipment relies on one post for its stability. Special attention should be paid to maintenance (e.g. by monitoring degradation) and if necessary decommissioning the item before the end of its operating life.

Medium

9

Consult with the manufacturer's guidance to determine suitable maintenance.

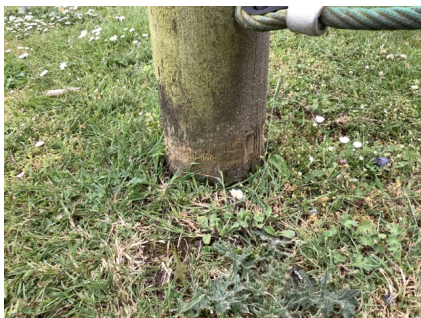
Strimmer damage to supports is likely to accelerate timber rot.

Medium

9

Prevent further damage.

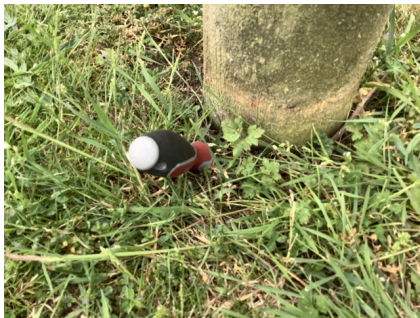
Timber is decayed.

Medium

11

Replace affected parts.

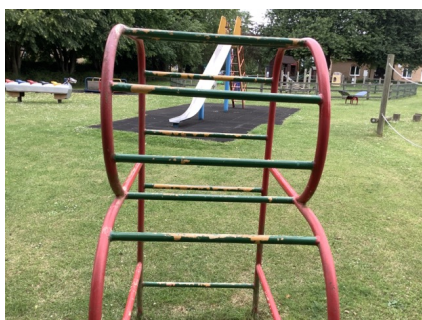
There is a head entrapment.

Low

5

No reasonably practicable action is identified.

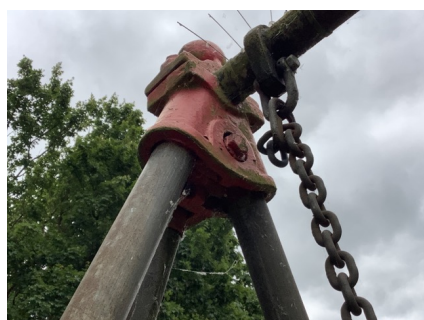
We are unable to gauge the structural integrity of this unit.

Medium

8

We advise an internal inspection of all parts or replacement.

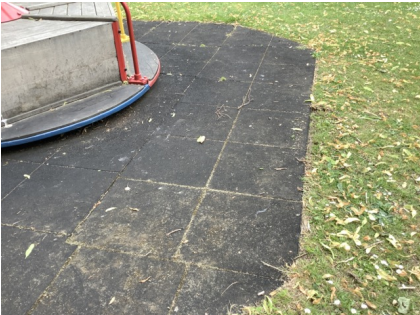
The safer surface has hard edging / foundation within the impact area.

The edging is within the 2 m surfacing area.

Medium

9

Modify to remove the hazard.

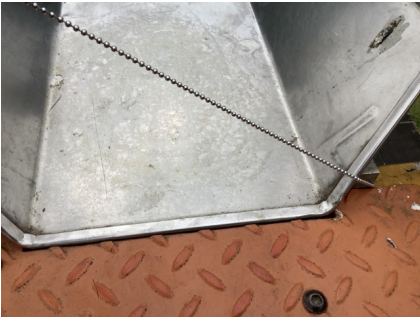
There is a toggle entrapment.

Low

6

No reasonably practicable action is identified.

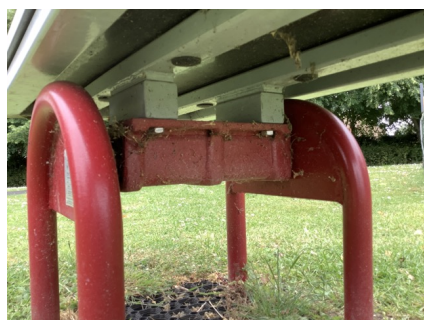
Additional comments are noted below.

The pivot rubber innards are worn. Replace.

Low

6

Replace.

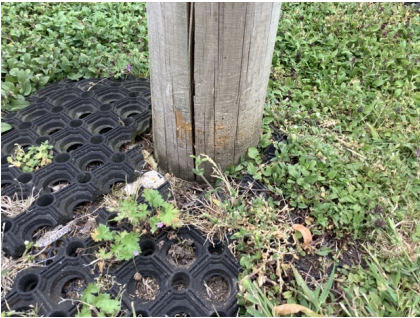
Strimmer damage to supports is likely to accelerate timber rot.

Low

6

Prevent further damage.

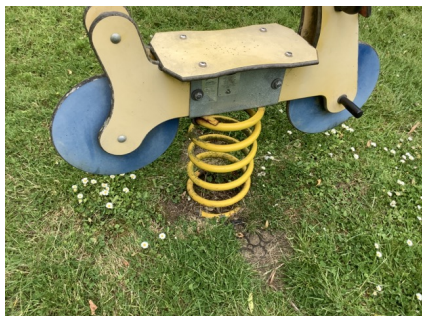
The supports are loose in the ground.

U it becoming loose in the ground.

7

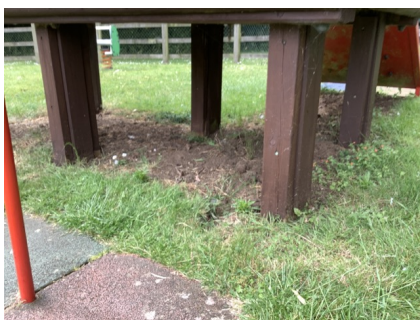
12

Replace rotten timbers.

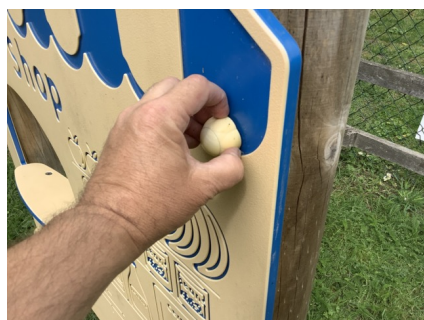
Fixtures loose or missing.

Panel bolt loose.

6

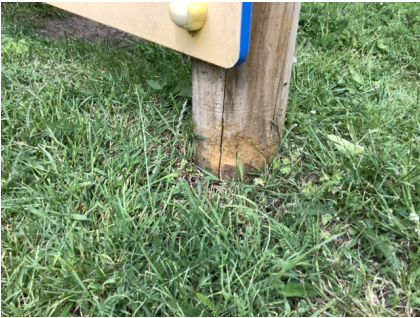
Strimmer damage to supports is likely to accelerate timber rot.

9

Prevent further damage.
