# Safety Inspection Report

Annual Inspection

## Orchard Lane

Woodnewton Parish Council

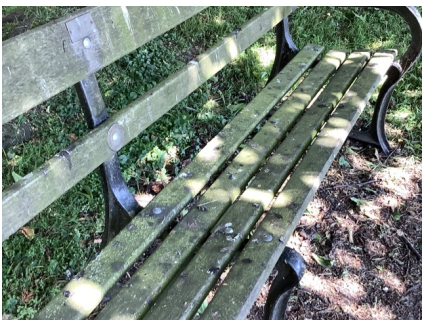
Bird fouling present.

It is recommended that playground equipment be regularly checked for bird fouling - if found, the affected items should be cleaned with a disinfectant solution.

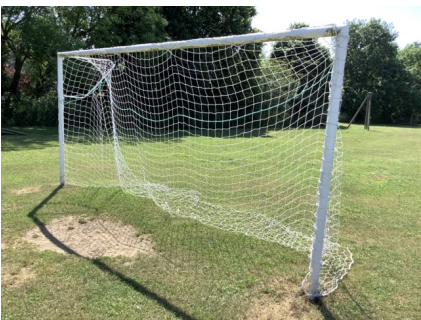
The structural tests within EN 748 / EN 16579 have not been done during this inspection. These can be conducted by separate arrangement.

Arrange to conduct the appropriate tests.

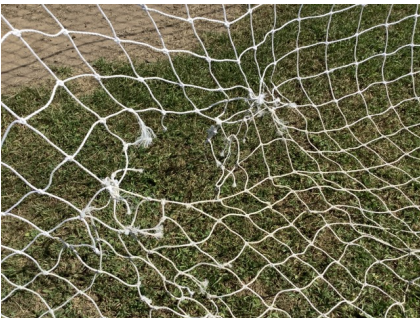
The net is damaged.

Repair the net.

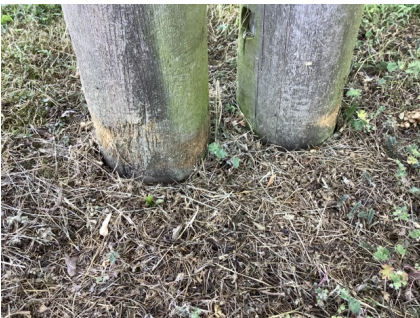
Strimmer damage to supports is likely to accelerate timber rot.

Prevent further damage.

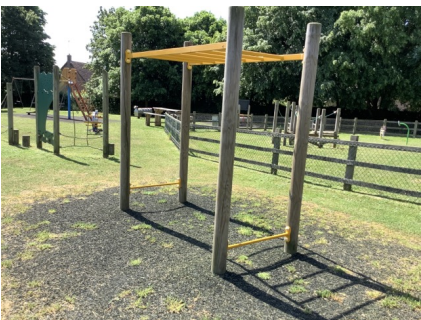
RoSPA is concerned by accidents on some types of overhead ladders and rings. However, there is a strong development value in these items.

The protective surface under all bars and rings must be kept in good condition.

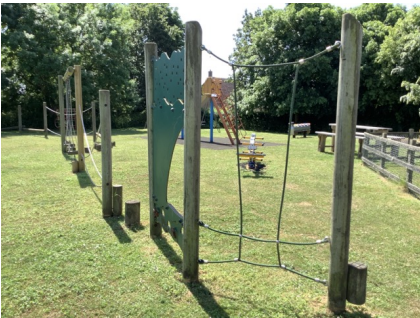
This equipment relies on one post for its stability. Special attention should be paid to maintenance (e.g. by monitoring degradation) and if necessary decommissioning the item before the end of its operating life.

Consult with the manufacturer's guidance to determine suitable maintenance.

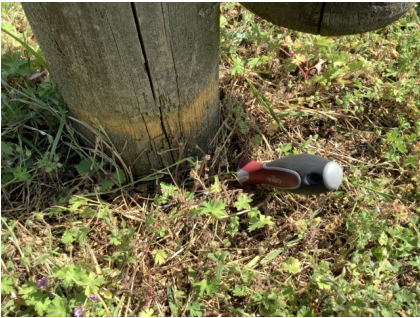
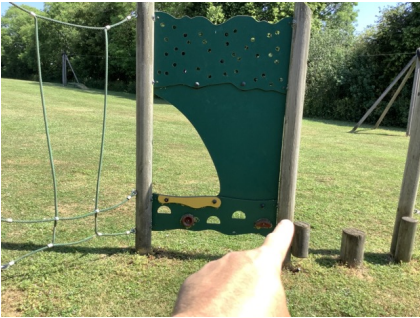
Timber is decayed.

Pod decayed and others softening on the rope walk and traverse wall unit.

Replace affected parts.

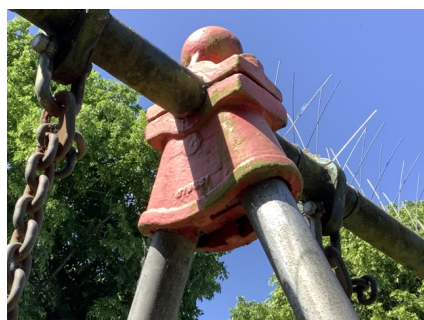
We are unable to gauge the structural integrity of this unit.

We advise an internal inspection of all parts or replacement.

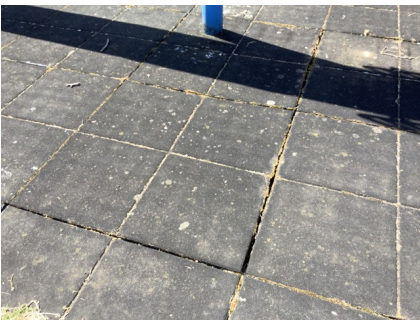
Gaps have opened up between tiles causing trip hazard.

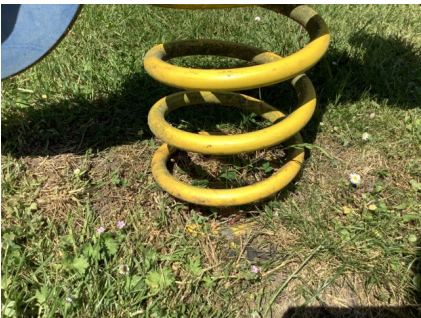
The supports are loose in the ground.

Unit becoming loose in the ground.

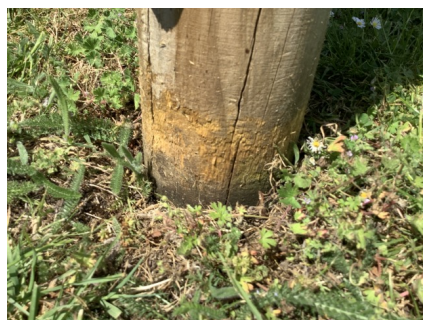
Strimmer damage to supports is likely to accelerate timber rot.

Prevent further damage.
