Safety Inspection Report

Annual Inspection

Orchard Lane

WoodNewton Parish Council

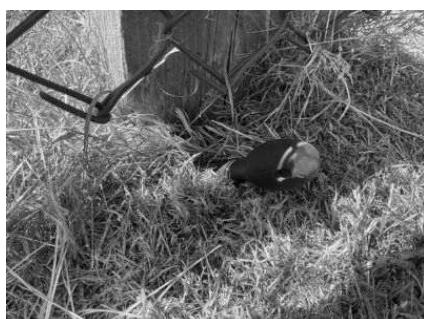
There is decay to timber components which may affect structural integrity. We do not recommend replacing rotten supports with timber posts which are directly set in the ground due to the increased problem of timber rot, especially in posts in contact with the ground.

Decay setting in due to heavy strimming. Replace affected parts.

Replace decayed components where possible and plan replacement of item. Check on a routine basis, especially at ground or foundation level.

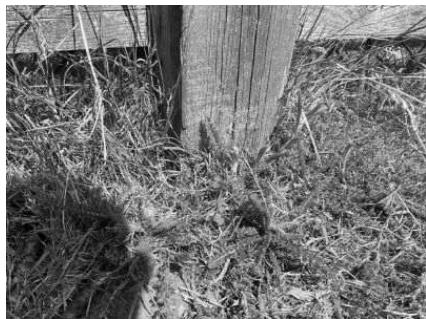
Strimmer damage is present on posts, allowing water to enter and timbers to soften. It can also remove the protective envelope around the timber. Prevent further damage and check timbers for decay throughout the year.

Prevent further damage.

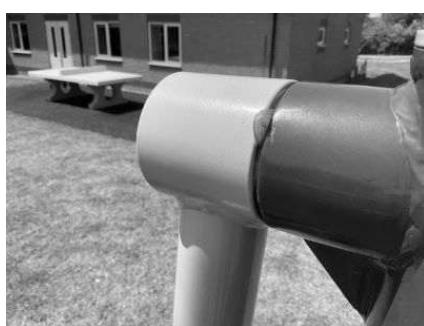
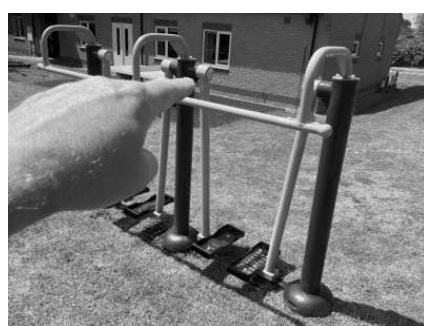
There is wear in the bearings.

The arm bearings are wearing. Gasket started to fall out. Service.

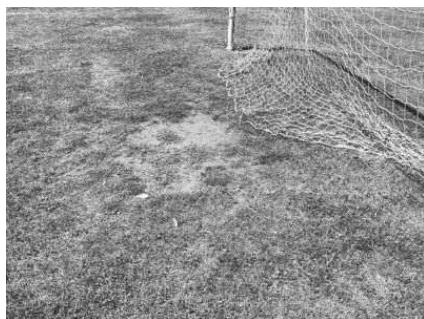
Goal mouth uneven. Level out.
Far side goal mouth has a deep hollow. Repair.

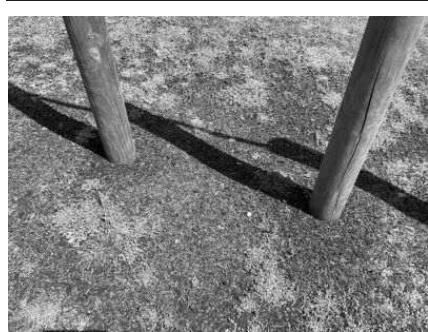
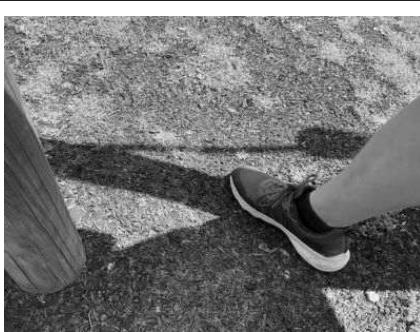
Surface needs repair.

Surfacing hollowing out between the posts and rubber has started to crack.

Repair.

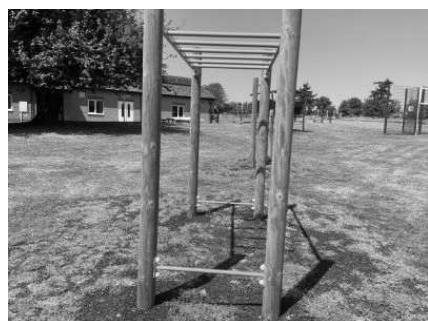
Overhead ladders and rings provide significant play value and benefits to children, and with it the risk of falling. Ensuring the surface remains in good condition will help to keep the correct balance between benefits and risk.

The protective surface under all bars and rings must be kept in good condition.

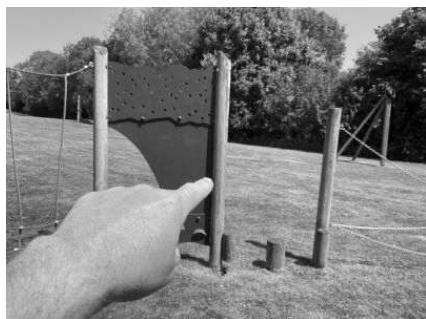
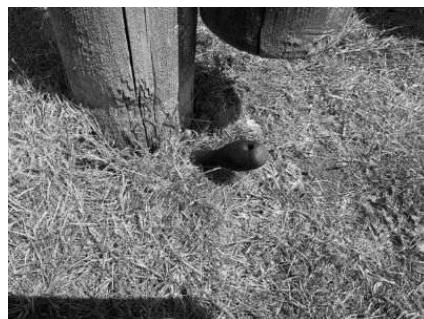
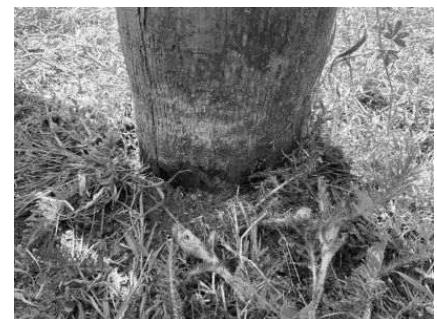
Timber is decayed.

Traverse wall end post decayed and stepping post adjacent has decayed, other timbers are softening at ground level.

Replace affected parts.

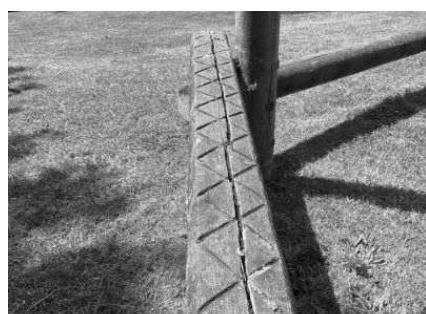
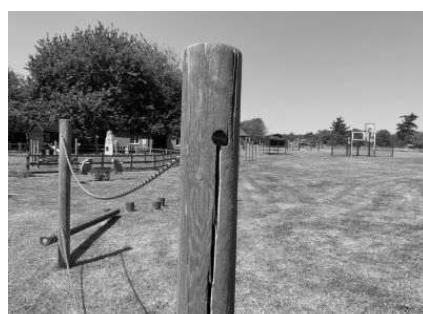
Monitor for decay starting within the shakes.

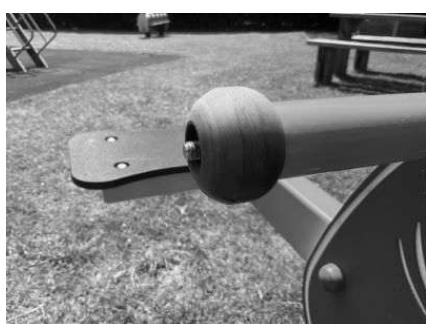
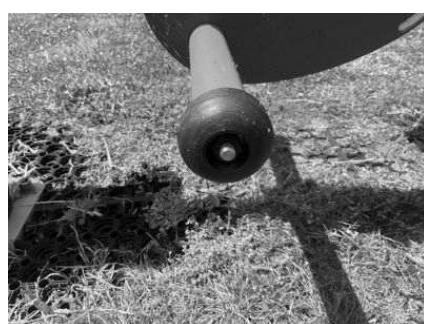
Cap missing.

Caps missing x 2.

Replace.

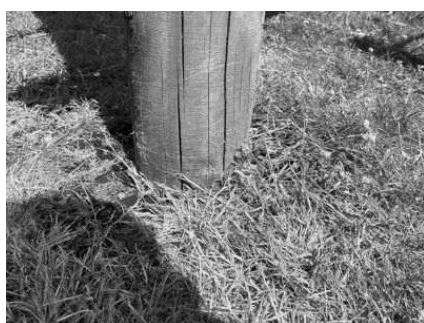
Strimmer damage is present on posts, allowing water to enter and timbers to soften. It can also remove the protective envelope around the timber. Prevent further damage and check timbers for decay throughout the year.

Prevent further damage.

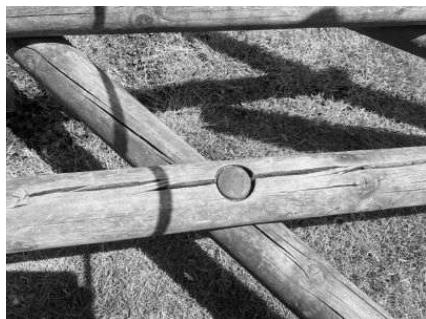
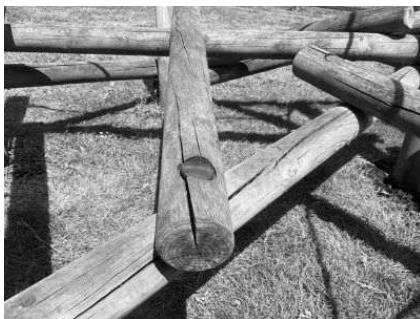
Logs working loose. Tighten all log fittings.

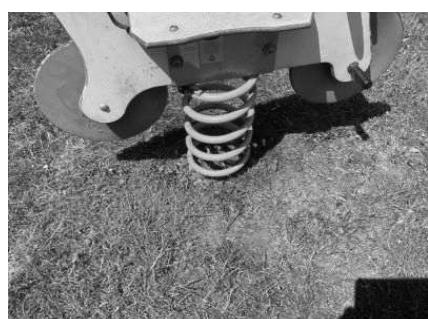
The supports are loose in the ground.

Unit becoming loose in the ground.

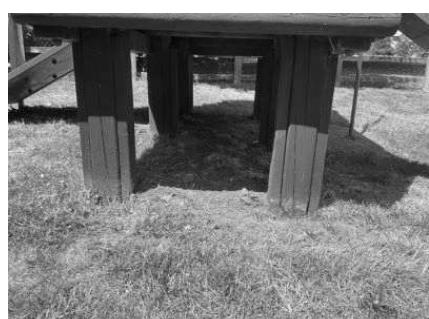
New supports added to previously rotting wood. RoSPA cannot guarantee the stability of this unit. Monitor for stability and rot.

Replace rotten timbers.

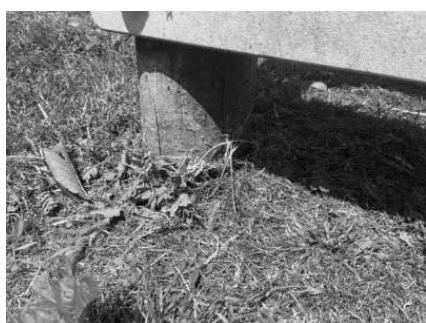
Strimmer damage is present on posts, allowing water to enter and timbers to soften. It can also remove the protective envelope around the timber. Prevent further damage and check timbers for decay throughout the year.

Prevent further damage.
