# Safety Inspection Report

Annual Inspection

## Orchard Lane

Site name: **Orchard Lane**  
Date of inspection: **13 June 2022**  
Inspector: **David Owen**

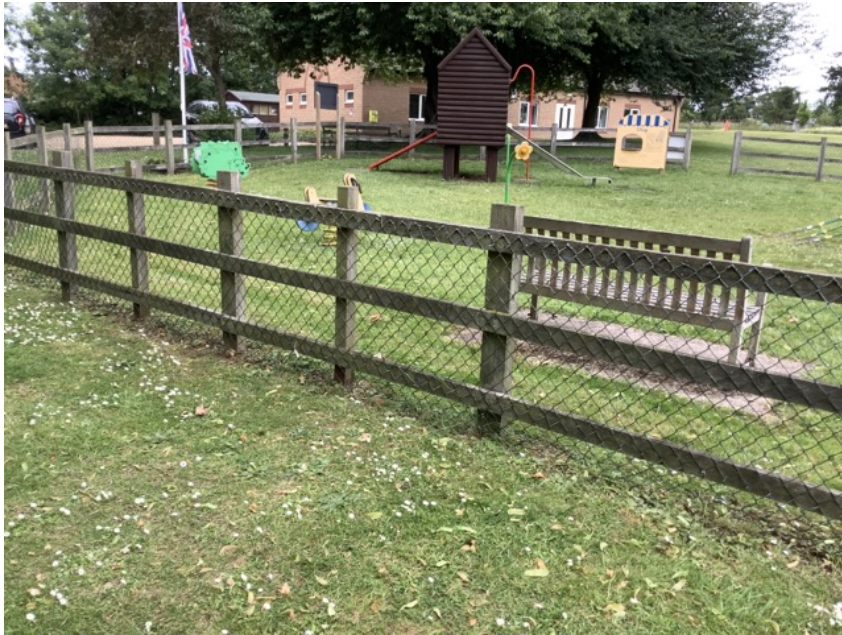
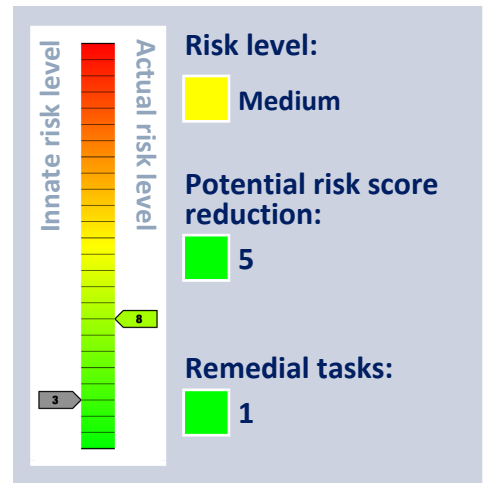
# Fencing

There is decay to timber components which may affect structural integrity. We do not recommend replacing rotten supports with timber posts which are directly set in the ground due to the increased problem of timber rot, especially in posts in contact with the ground.

Decay setting in due to heavy strimming. Replace affected parts.

Replace decayed components where possible and plan replacement of item. Check on a routine basis, especially at ground or foundation level.

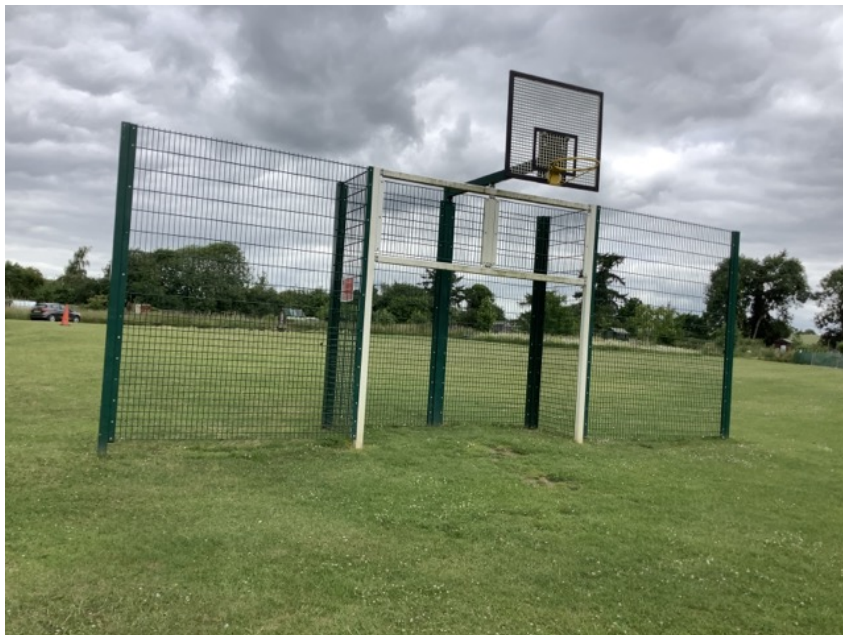
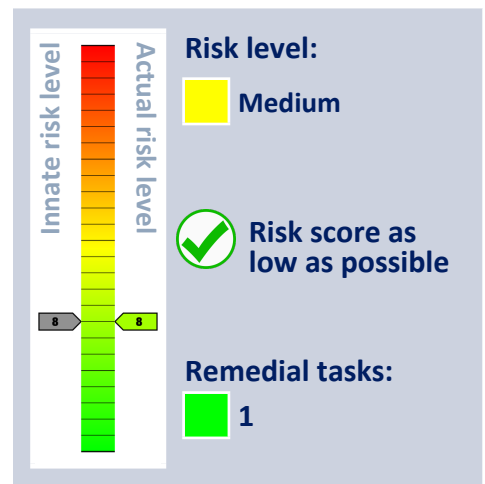
# MUGA - Single End

Surface is wearing.

Goalmouth/s wearing. Either soil & seed affected area or re-turf affected area.

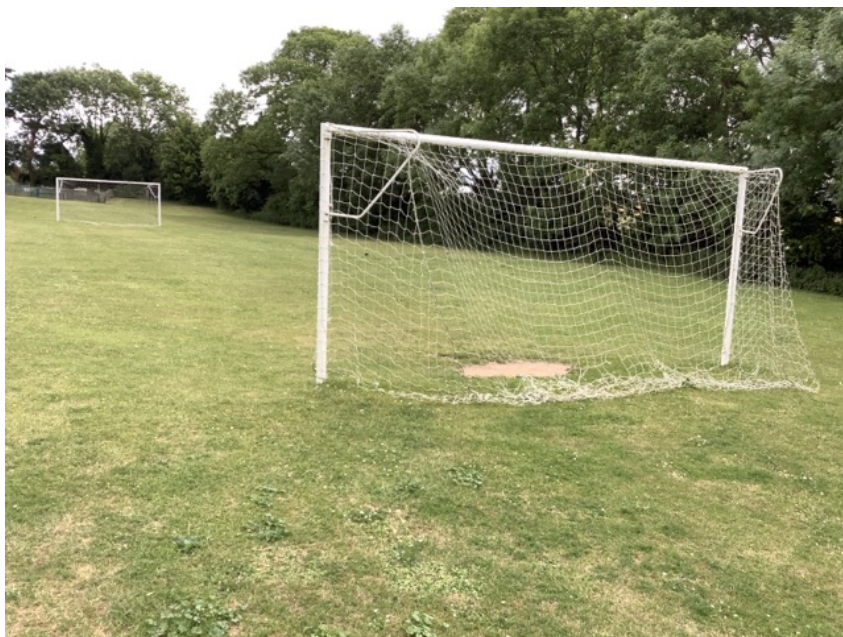
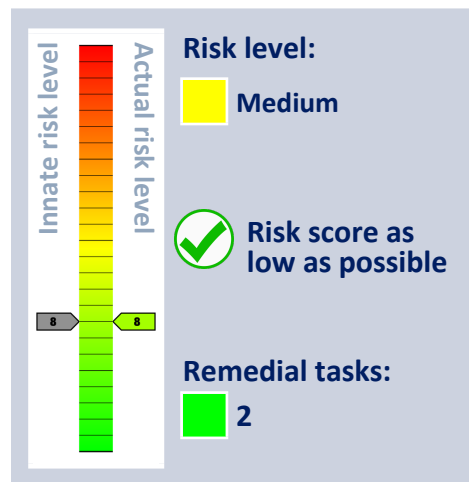
# Goal Posts

Goalmouth repairs uneven. Level out.  
Far side goalmouth has a deep hollow. Repair.

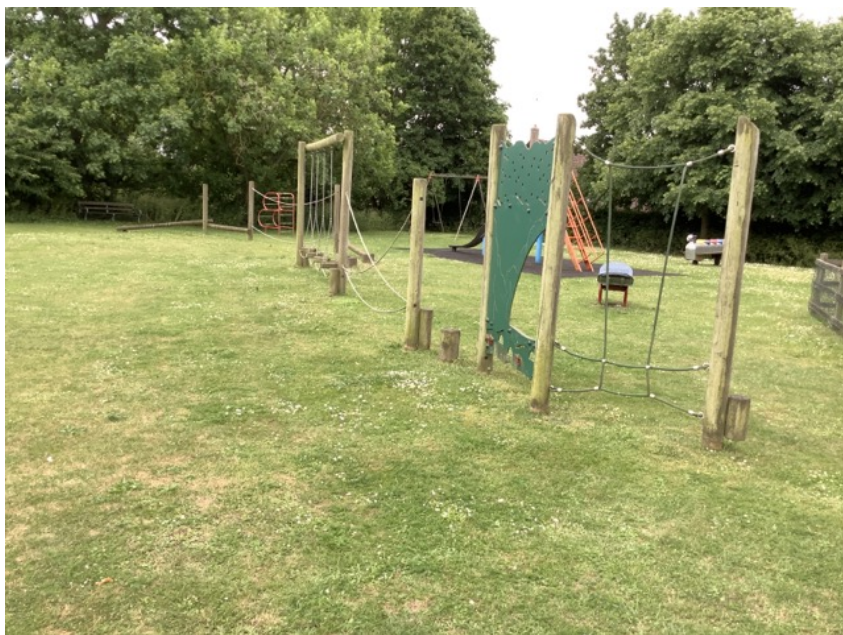
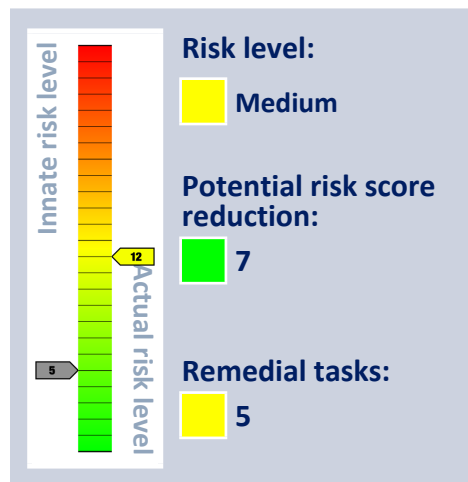
# Agility Trail - Timber

This equipment relies on one post for its stability. Special attention should be paid to maintenance (e.g. by monitoring degradation) and if necessary decommissioning the item before the end of its operating life.

Strimmer damage to supports is likely to accelerate timber rot.

Timber is decayed.

Centre post to the chain walk and suspended log walk has split and there is a possibility of splitting in too. Recommend replacing the post.

Prevent further damage.

Replace affected parts.

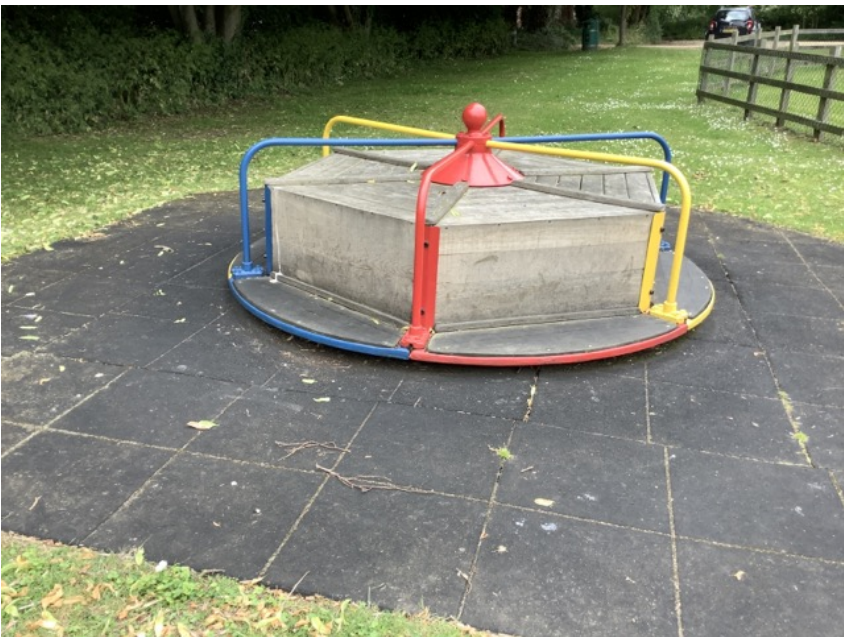
# Carousel (1978)

Gaps have opened up between tiles causing trip hazard.

The safer surface has hard edging / foundation within the impact area.

Modify to remove the hazard.

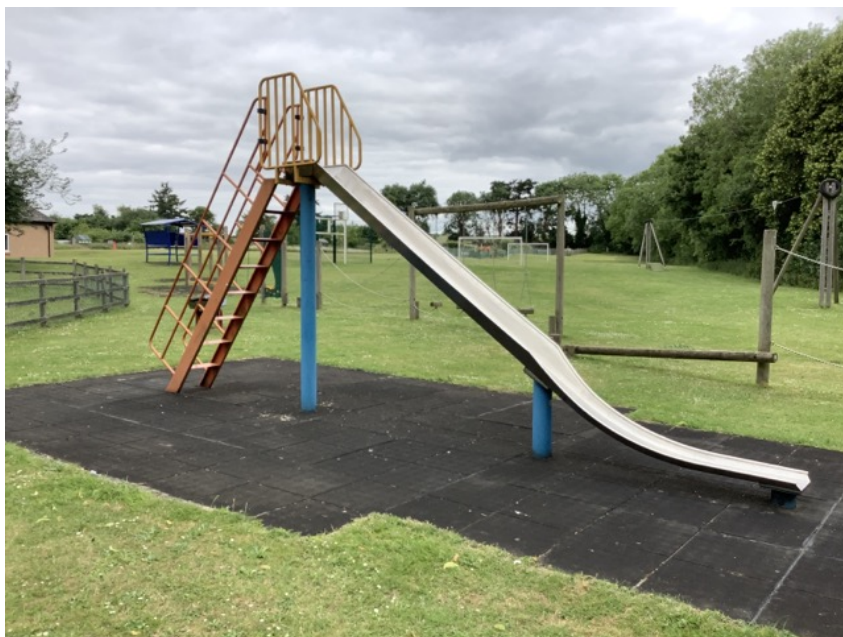
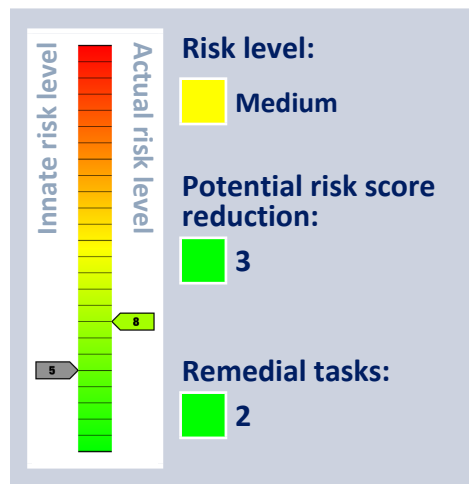
# Slide

Gaps have opened up between tiles causing trip hazard.

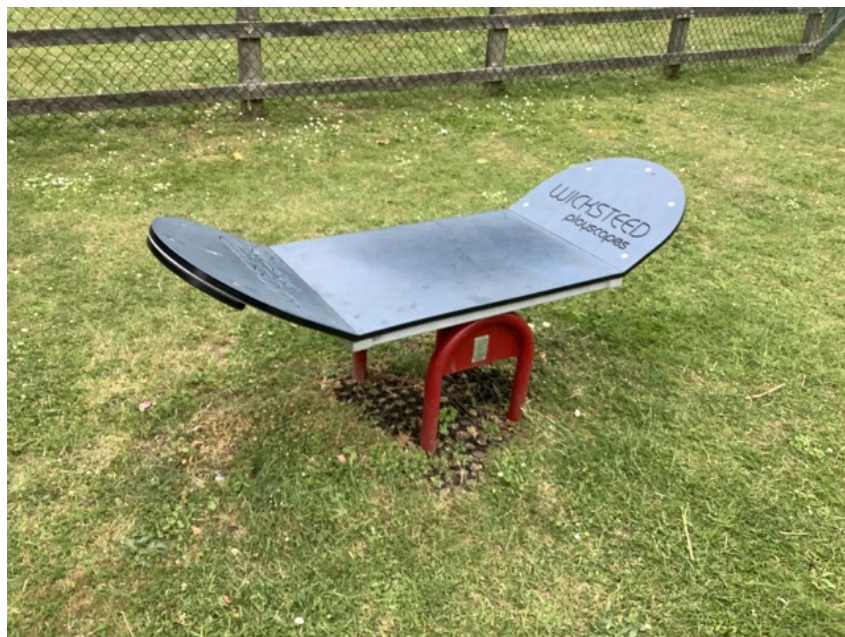
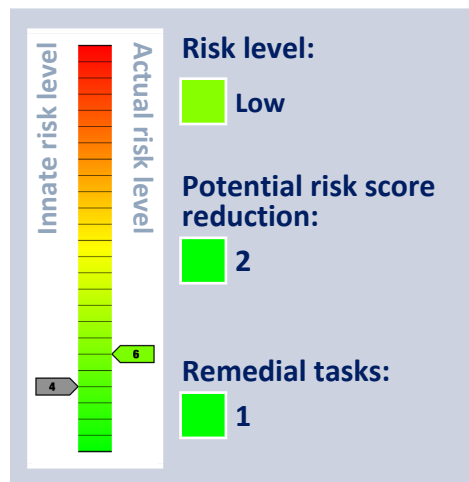
# Rocker - Surfboard

The pivot rubber innards are worn. Replace.

Replace.

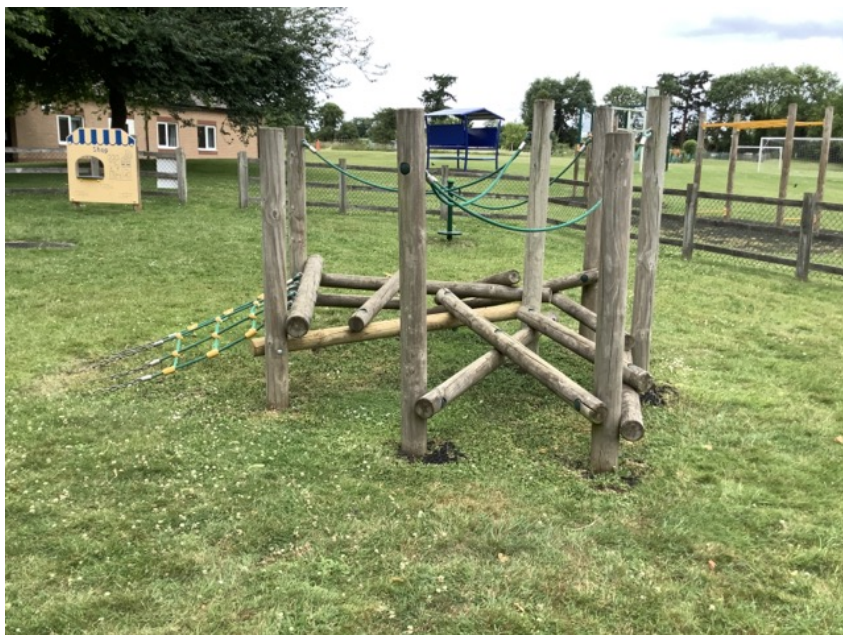
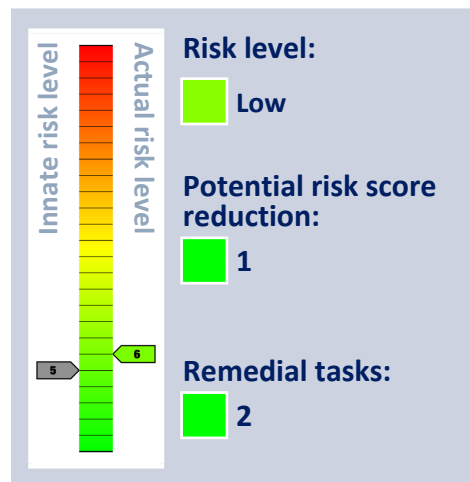
# Climber

Strimmer damage to supports is likely to accelerate timber rot.

Prevent further damage.

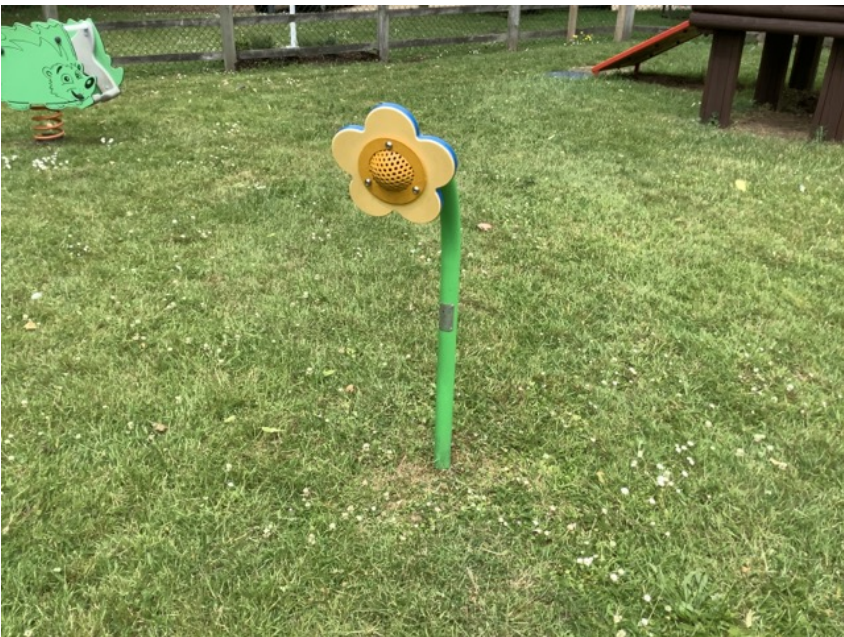
# Talk Tubes

The supports are loose in the ground.

Fixtures loose or missing.

Panel bolt loose.

Strimmer damage to supports is likely to accelerate timber rot.

Replace rotten timbers.

Prevent further damage.
