Safety Inspection Report

Annual Inspection

Orchard Lane

WoodNewton Parish Council

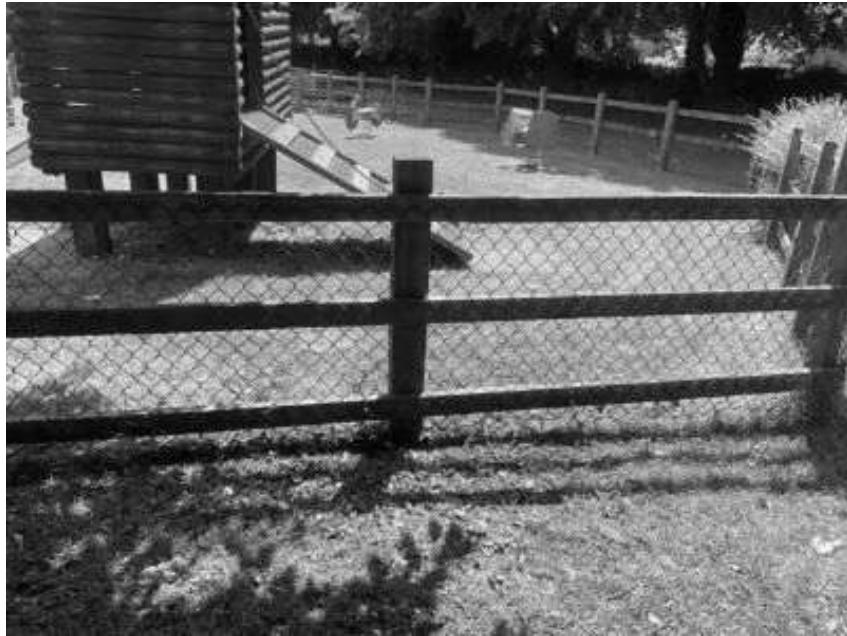
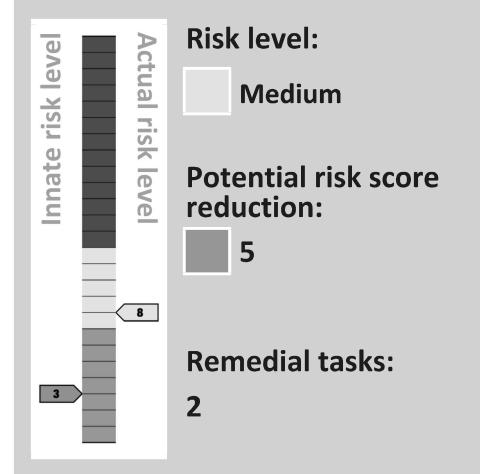
Fencing

There is decay to timber components which may affect structural integrity. We do not recommend replacing rotten supports with timber posts which are directly set in the ground due to the increased problem of timber rot, especially in posts in contact with the ground.

Replace decayed components where possible and plan replacement of item. Check on a routine basis, especially at ground or foundation level.

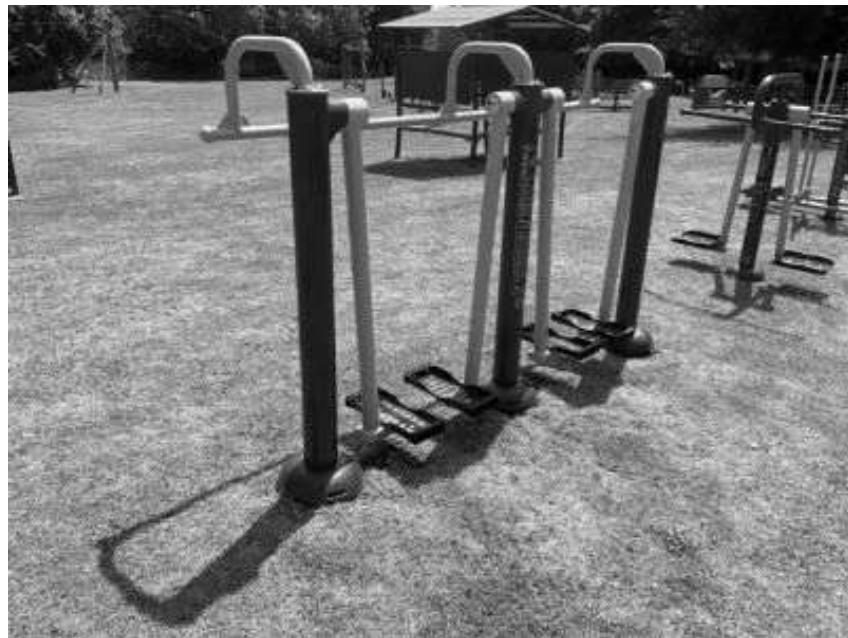
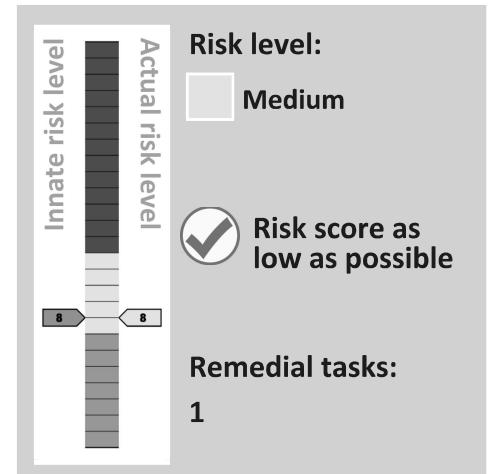
Adult Fitness - Air Walk

There is wear in the bearings.

The arm bearings are wearing. Gasket started to fall out. Service.

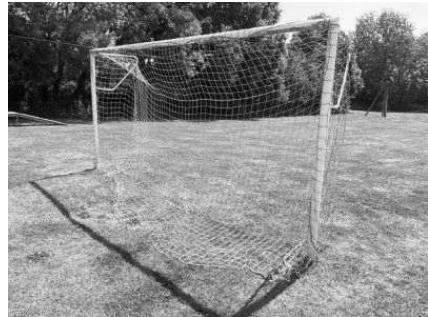
Goal mouth uneven. Level out.
Far side goal mouth has a deep hollow. Repair.

Arrange to conduct the appropriate tests.

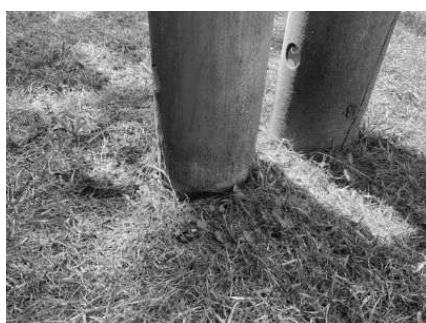
Strimmer damage is present on posts, allowing water to enter and timbers to soften. It can also remove the protective envelope around the timber. Prevent further damage and check timbers for decay throughout the year.

Prevent further damage.

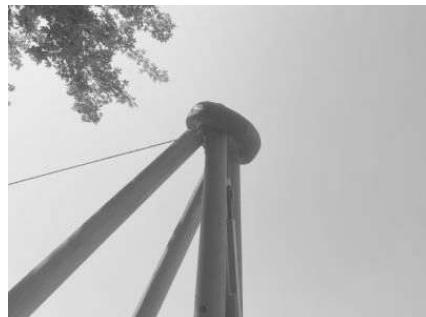
Additional comments are noted below.

Remove tyres from the top of both supports.

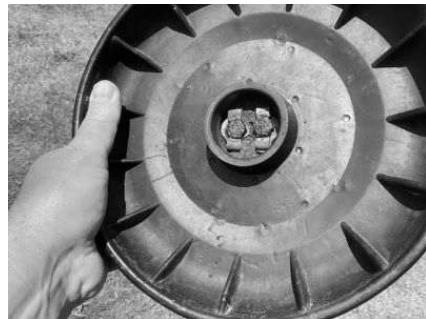
Fittings are rusty.

Seat fixing bolts.

Replace.

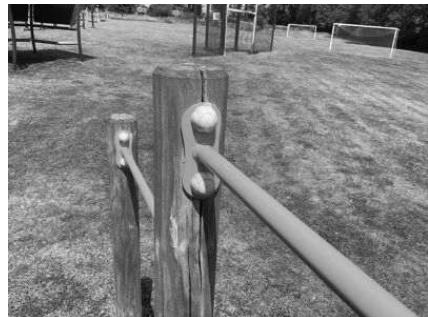
DO NOT fill shakes. There are shakes running through fixing points. Ensure the fixings are fully secure on regular basis.

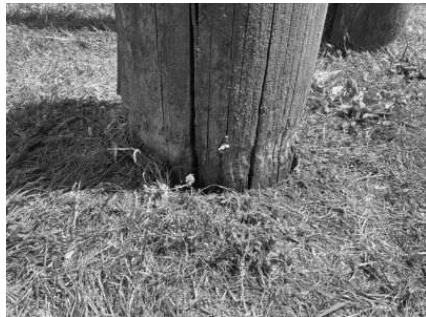
Timber is decayed.

Traverse wall end post decayed and stepping post adjacent has decayed, other timbers are softening at ground level.

Replace affected parts.

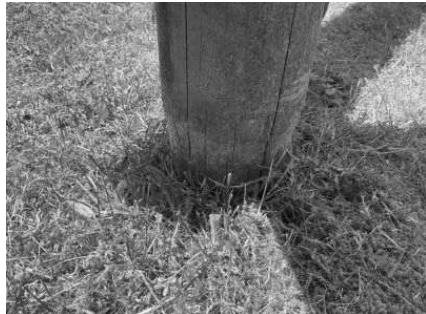
Strimmer damage is present on posts, allowing water to enter and timbers to soften. It can also remove the protective envelope around the timber. Prevent further damage and check timbers for decay throughout the year.

Prevent further damage.

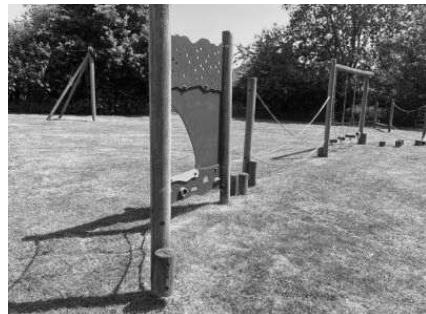
This equipment relies on one post for its stability. Special attention should be paid to maintenance (e.g. by monitoring degradation) and if necessary decommissioning the item before the end of its operating life. This is a requirement of the British Standard.

Consult with the manufacturer's guidance to determine suitable maintenance.

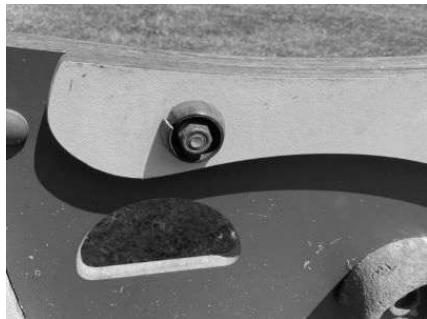
Cap missing.

Replace.

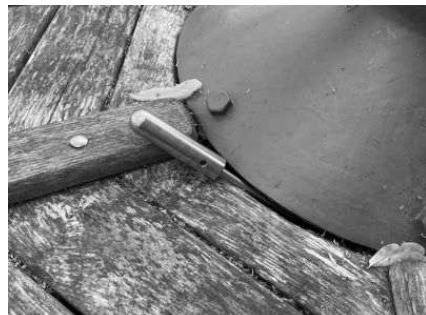
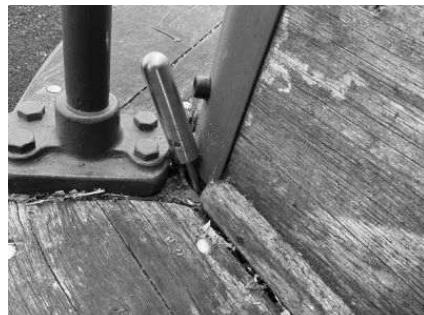
Various finger entrapments within the unit.

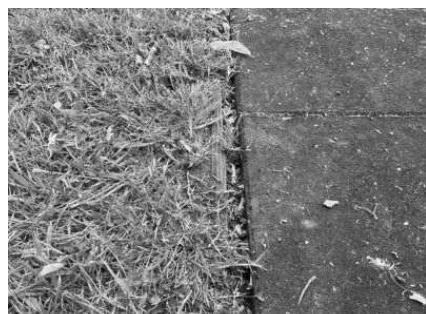
The safer surface has hard edging / foundation within the impact area.

The timber edging is within the 2 m surfacing area.

Modify to remove the hazard.

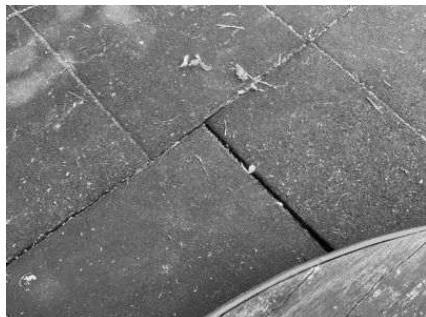
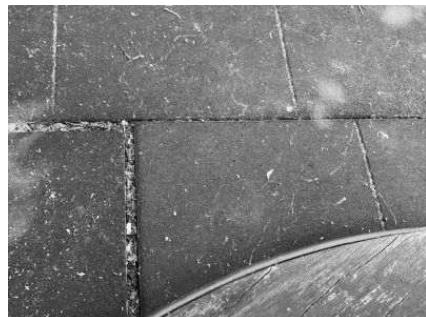
Gaps have opened up between tiles causing trip hazard.

Gaps in tiles is exposing the concrete sub base.

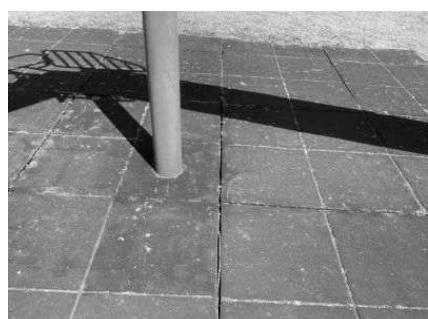
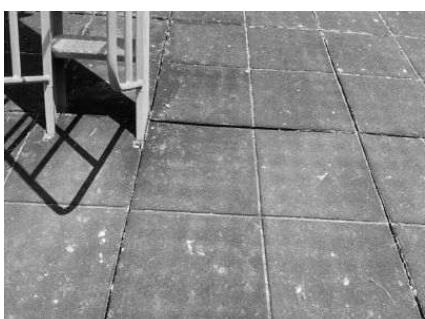
Gaps have opened up between tiles causing trip hazard.

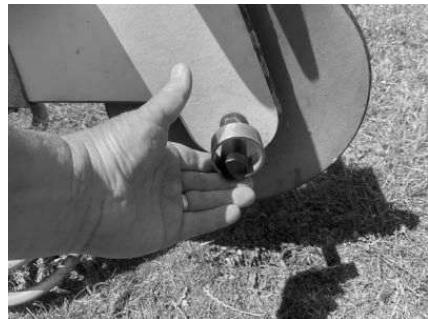
The supports are loose in the ground.

Unit becoming loose in the ground.

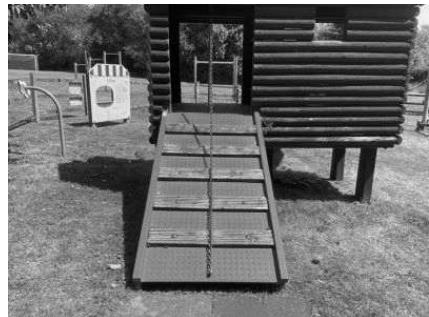
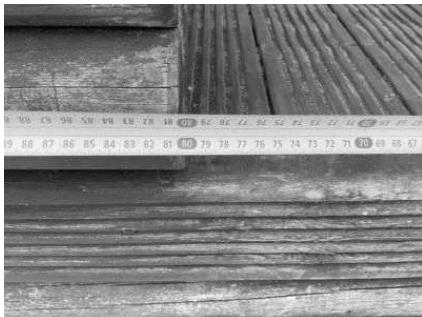
New supports added to previously rotting wood. RoSPA cannot guarantee the stability of this unit. Monitor for stability and rot.

Replace rotten timbers.
