Safety Inspection Report

Annual Inspection

Orchard Lane

15 June 2021

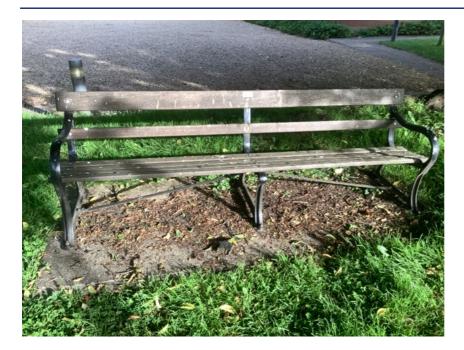
Seating

Bird fouling present.

Encroaching vegetation or trees.

Cut back vegetation to seat near cableway.

It is recommended that playground equipment be regularly checked for bird fouling - if found, the affected items should be cleaned with a disinfectant solution.

Remove.

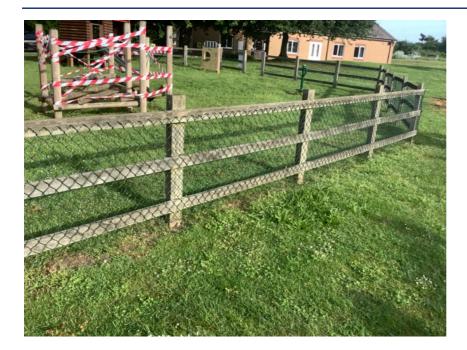
Fencing

There is decay to timber components which may affect structural integrity. We do not recommend replacing rotten supports with timber posts which are directly set in the ground due to the increased problem of timber rot, especially in posts in contact with the ground.

Decay setting in due to heavy strimming. Replace affected parts..

Replace decayed components where possible and plan replacement of item. Check on a routine basis, especially at ground or foundation level.

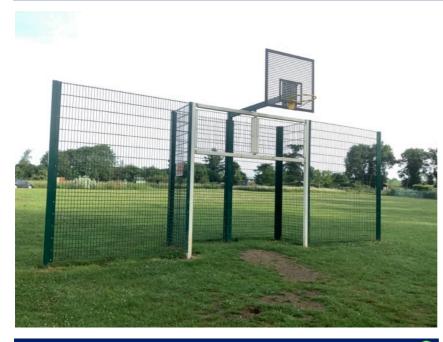
MUGA - Single End

Surface is wearing.

Goalmouth/s wearing. Either soil & seed affected area or re-turf affected area.

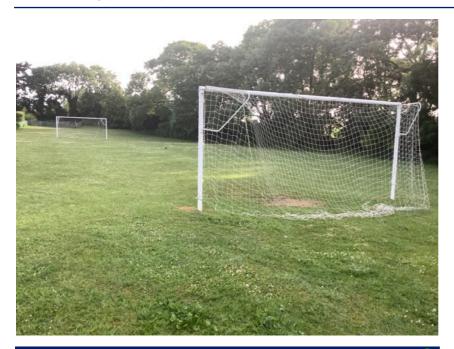
Goal Posts

Fixtures loose or missing.

Stanchion detached from the frame.

Surface is uneven.

Goalmouth repairs uneven. Level out. Far side goalmouth has a deep hollow. Repair

Tighten.

Make good.

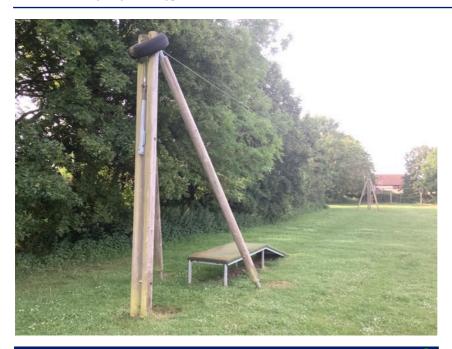
Cableway

Remove tyres from the top of both supports.

Strimmer damage to supports is likely to accelerate timber rot.

Prevent further damage.

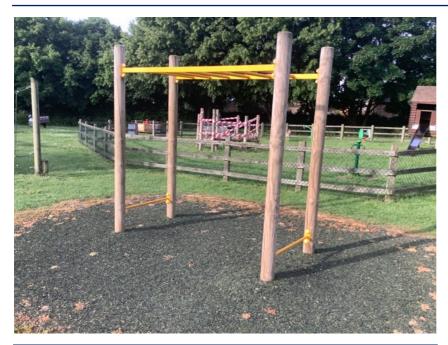
Agility - Horizontal Ladder

RoSPA is concerned by accidents on some types of overhead ladders and rings. However, there is a strong development value in these items.

The protective surface under all bars and rings must be kept in good condition.

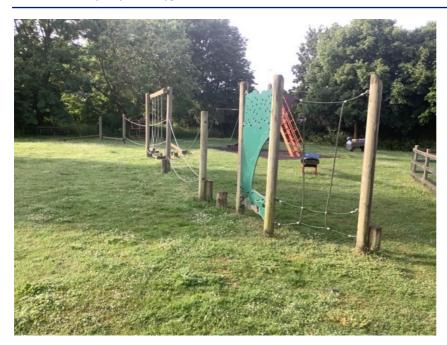
Agility Trail - Timber

This equipment relies on one post for its stability. Special attention should be paid to maintenance (e.g. by monitoring degradation) and if necessary decommissioning the item before the end of its operating life.

There are natural splits / shakes in the timbers.

Strimmer damage to supports is likely to accelerate timber rot.

Timber is smashed.

Centre post to the chain walk and suspended log walk has split and there is a possibility of splitting in too. Recommend replacing the post.

Consult with the manufacturer's guidance to determine suitable maintenance.

Shakes vary. Monitor and consult manufacturer if dimensions exceed 8 mm at sections used to grip / grasp.

Prevent further damage.

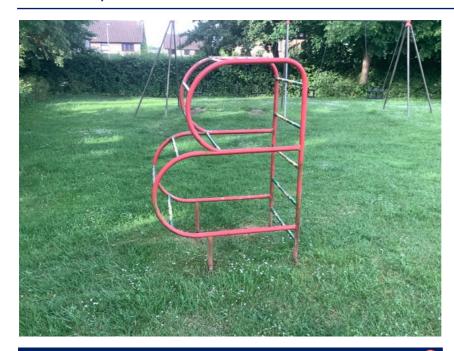
Climber - B Frame

The item or its surfacing are not compliant with the requirements of the relevant standards.

There is a head entrapment.

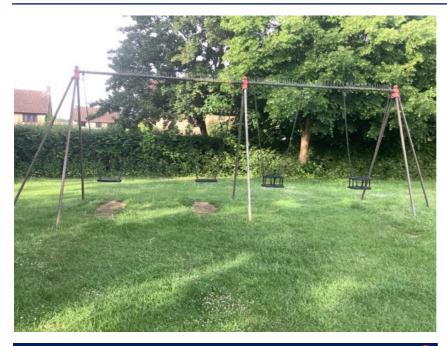
Swing - Mixed - 2 Bay 2 Junior 2 Toddler Seat

The item or its surfacing are not compliant with the requirements of the relevant standards.

The distance between the seat side and the support is insufficient.

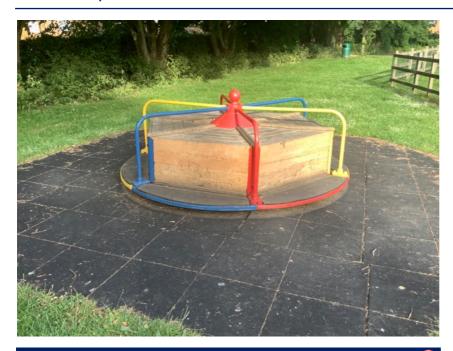
Carousel (1978)

Gaps have opened up between tiles causing trip hazard.

The safer surface has hard edging / foundation within the impact area.

The edging is within the 2 m surfacing area.

Re-glue and fill gaps and joints as necessary.

Modify to remove the hazard.

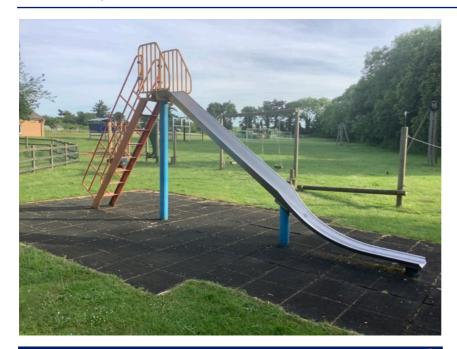
Slide

Gaps have opened up between tiles causing trip hazard.

There is a toggle entrapment.

Re-glue and fill gaps and joints as necessary.

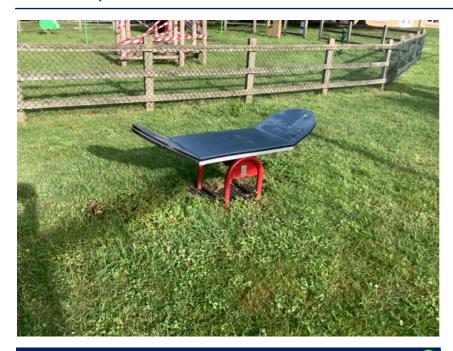
Rocker - Surfboard

The rubber innards are worn. Replace

Replace.

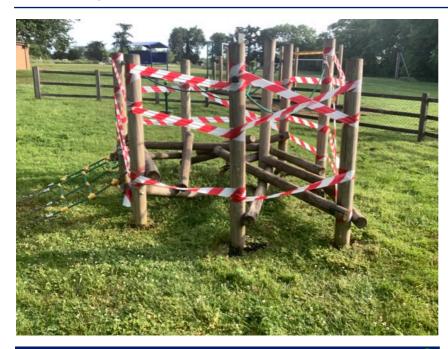
Climber

There is decay to timber components which may affect structural integrity. We do not recommend replacing rotten supports with timber posts which are directly set in the ground due to the increased problem of timber rot, especially in posts in contact with the ground.

Cross beam has decayed from the inside out and collapsed. The unit has been cordoned off from use. Replace beam.

Replace decayed components where possible and plan replacement of item. Check on a routine basis, especially at ground or foundation level.

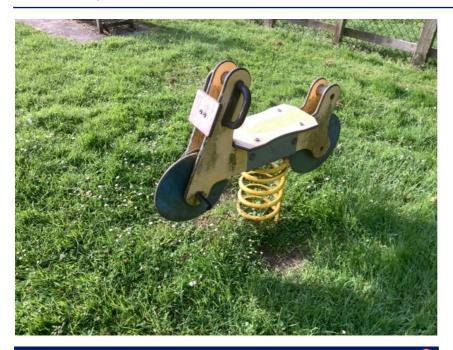
Rocker - Bike

The item or its surfacing are not compliant with the requirements of the relevant standards.

Protruding handles / foot rests.

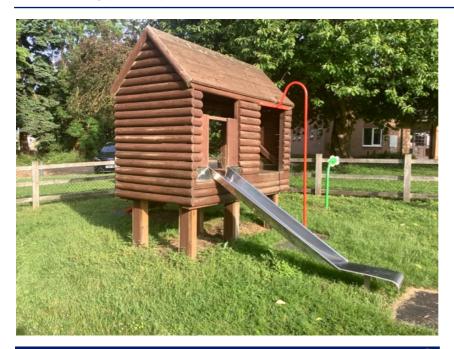
Slide - Cabin

Timber is rotting.

New supports added to previously rotting wood, RoSPA cannot guarantee the stability of this unit.

The opening in the barrier is wider than 500 mm (when measured horizontally at any point), but there is no guardrail.

Replace rotten timbers.

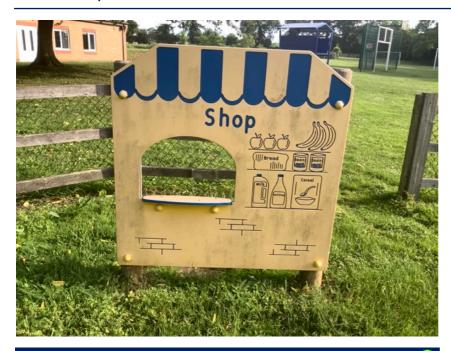
Play Panel - Shop

Fixtures loose or missing.

Panel bolt loose.

Strimmer damage to supports is likely to accelerate timber rot.

Tighten.

Prevent further damage.
