# Safety Inspection Report

Annual Inspection

## Orchard Lane

Woodnewton Parish Council

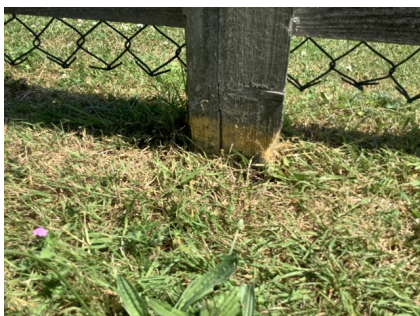
There is decay to timber components which may affect structural integrity. We do not recommend replacing rotten supports with timber posts which are directly set in the ground due to the increased problem of timber rot, especially in posts in contact with the ground.

Decay setting in due to heavy strimming. Replace affected parts.

Replace decayed components where possible and plan replacement of item. Check on a routine basis, especially at ground or foundation level.

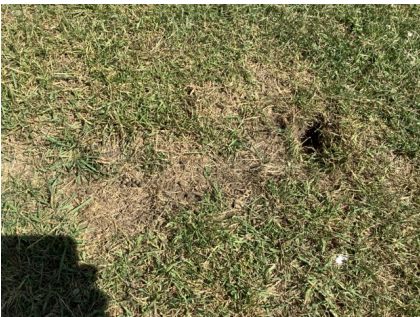
Surface is wearing.

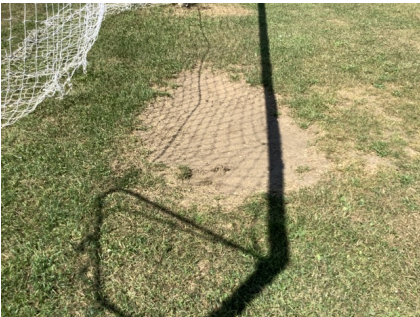
The net is damaged.

Goal mouth repairs uneven. Level out.  
Far side goal mouth has a deep hollow. Repair.

Repair the net.

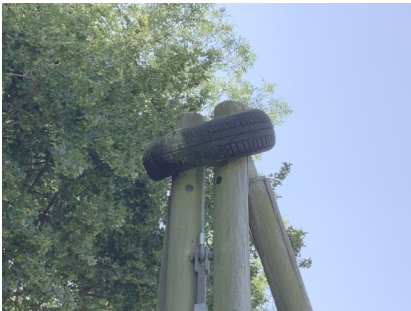
Strimmer damage to supports is likely to accelerate timber rot.

Prevent further damage.

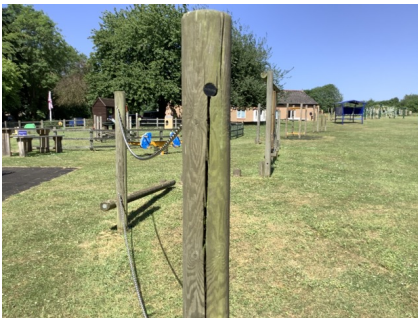
Strimmer damage to supports is likely to accelerate timber rot.

Prevent further damage.

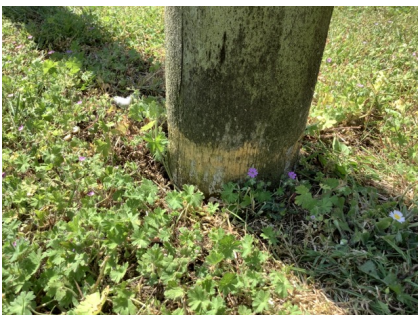
Timber is decayed.

Pod decayed and others softening on the rope walk and traverse wall unit.

Replace affected parts.

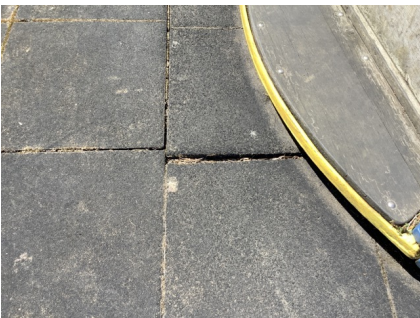
Gaps have opened up between tiles causing trip hazard.

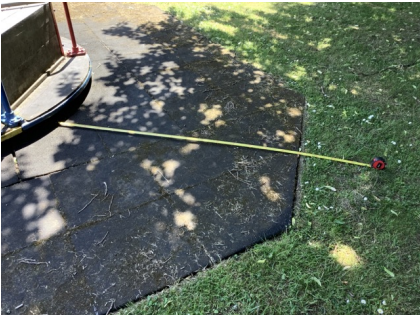
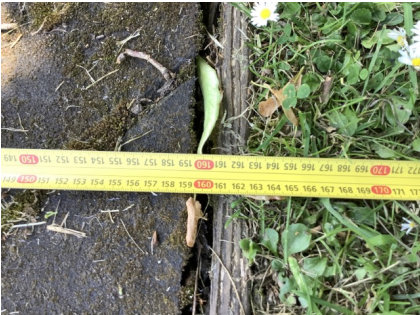
The safer surface has hard edging / foundation within the impact area.

Modify to remove the hazard.

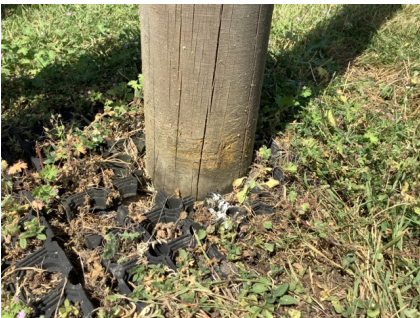
Strimmer damage to supports is likely to accelerate timber rot.

Prevent further damage.

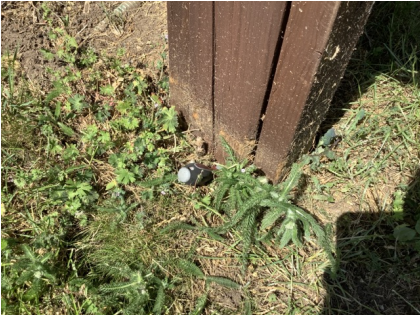
New supports added to previously rotting wood. RoSPA cannot guarantee the stability of this unit. Monitor for stability and rot.

Replace rotten timbers.
